The University of Hong Kong

Final Report

**Research on Energy Management and Power
Quality**

Tseung Kwan O Hospital

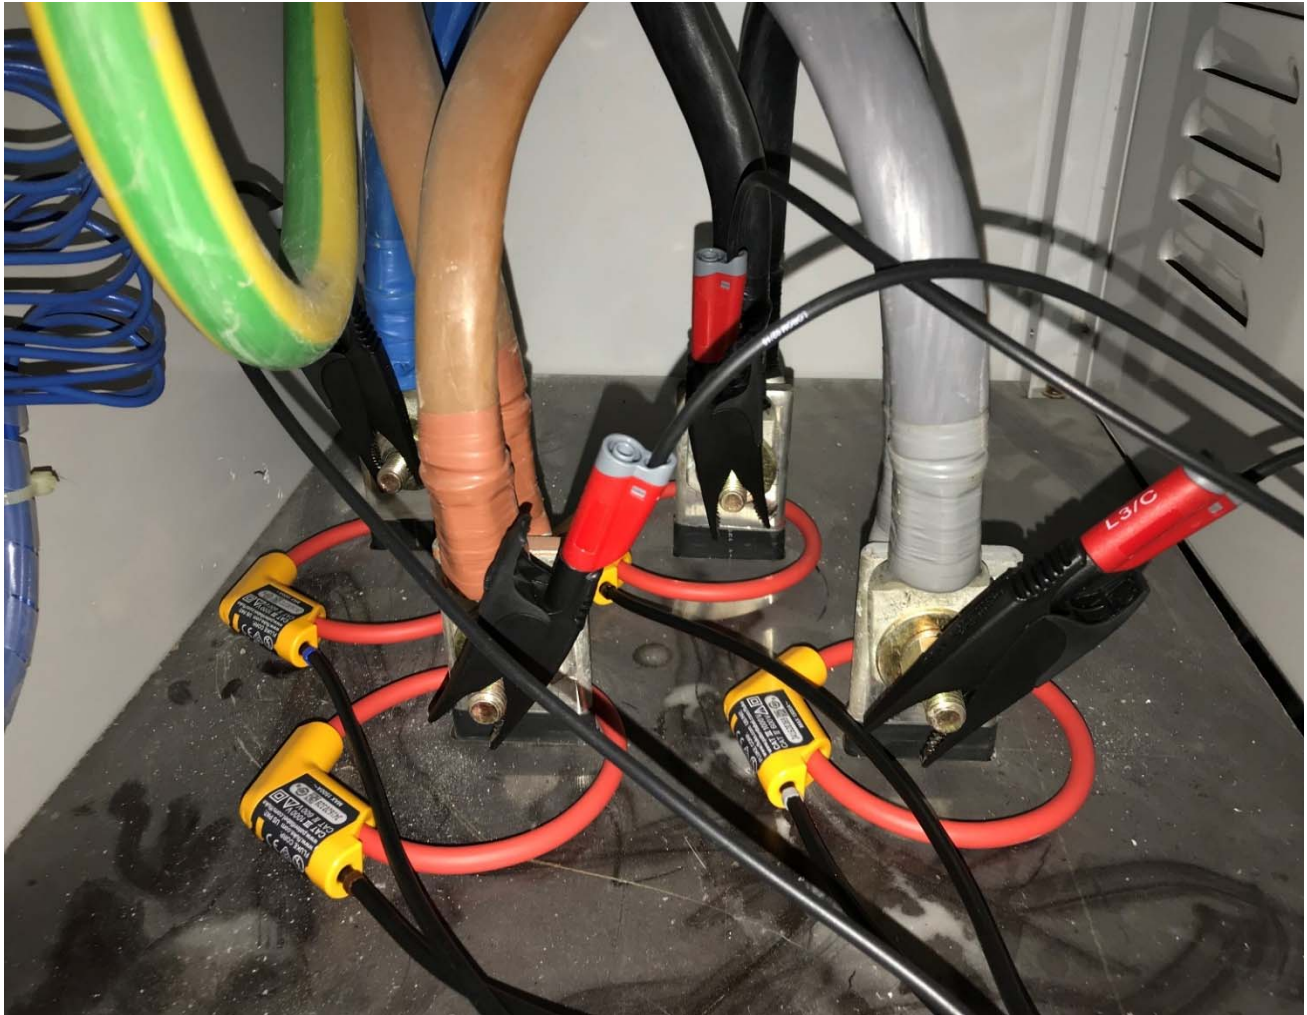
Figure 4.4.2.1 Set Up for Capacitor Bank Measurement

During the two site measurement, there is no specific findings and the data obtained shows that there is no connection and usage of the capacitor bank. As reported by the technical staff of the building, the upper limit of the target power factor is changed to 0.93 inductive, to prevent overshoot after the operation of capacitor bank. Seemingly with the new setting of the upper limit in the control algorithm, the capacitor banks are operating satisfactorily and no subsequent problems have been reported.

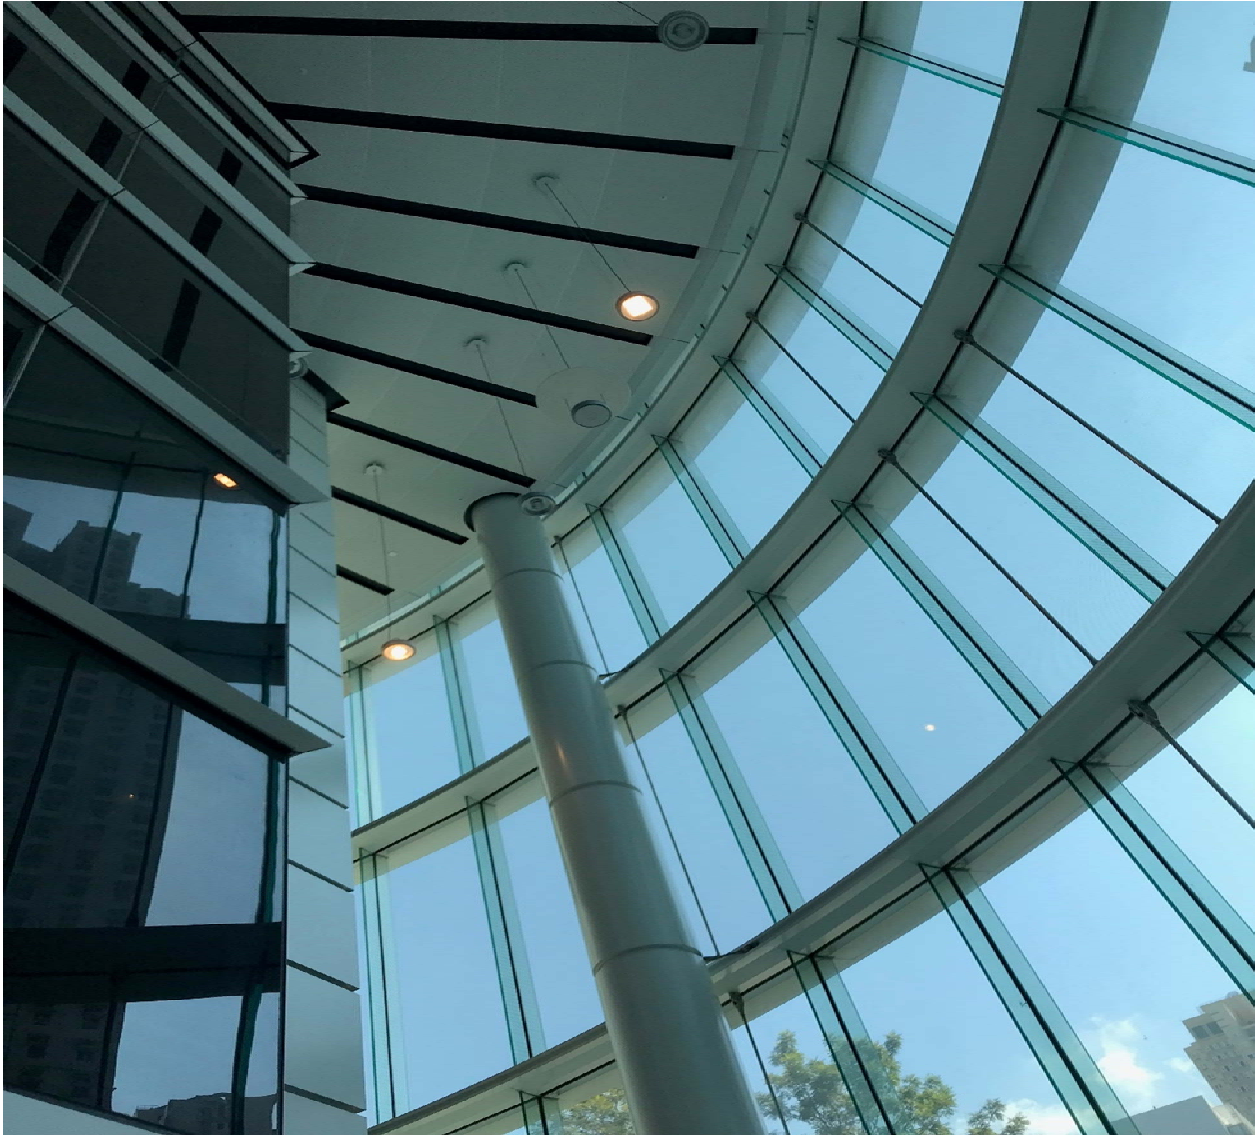
Figure 5.1.2 Redundant Luminaires Spotted in ACB

Apart from excessive lighting, redundant luminaire is one of the possible reasons causing immoderate illuminance level. In site visit conducted on 8th August 2018, some redundant luminaires are noticed in the building. Figure 5.1.2 shows an example of redundant luminaires found in the building.

Apart from showing the luminaires, Figure 5.1.2 shows the exterior design of the building, which make good use of glass facade. This facade design allows natural light from broader directions to enter, so as to reduce the use of power in lighting system. The luminaires shown are not useful during sunny daytime, as the natural light is adequate for occupants; while at cloudy daytime or at night, the light from these luminaires would perform their intended functions. The luminaires identified are recommended to remain power-off when there is sufficient natural lighting. The detailed recommendations will be explained in Chapter 6.c.

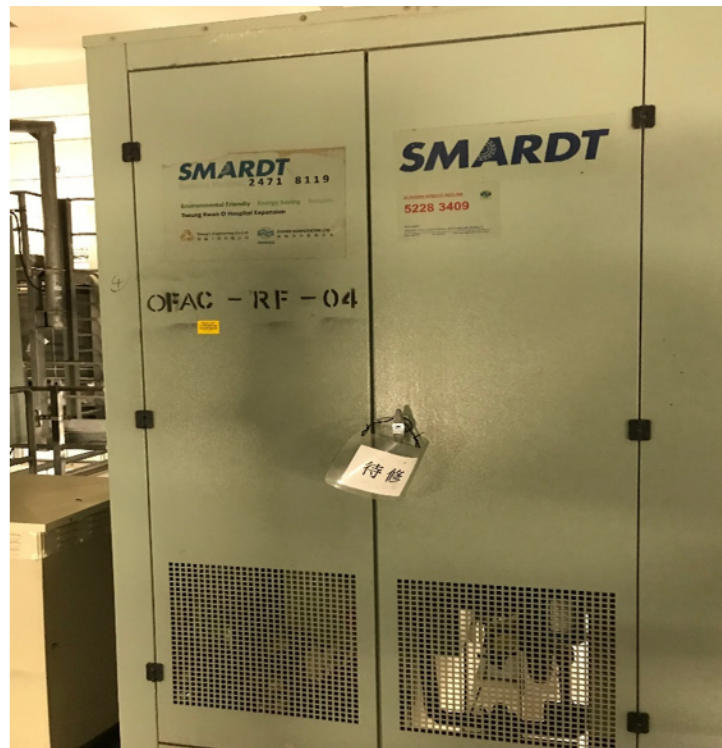
Figure 5.2.1: Photo of OFAC_RF2_04 on 4th June 2018

The chiller OFAC_RF2_04 and OFAC_RF2_01 are reported to have a long period of malfunctioning during the period from 2016 – 2017. During the site visit dated 4th June 2018, the chiller OFAC_RF2_04 is still not functioning, some functional parts of that chiller is used to replace the malfunctioning part of OFAC_RF2_01. Figure 5.2.1 is a photo of OFAC_RF2_04 taken on 4th June 2018, showing a tag “pending for maintenance” is attached to the chiller.

The prolonged malfunctioning of OFAC_RF2_04 is affecting the loading distribution of the whole chiller system. Given the energy saving in the long run together with the longer life expectancy of equipment, it is recommended that the malfunctioning chiller should be repaired as soon as possible.
